# **Department of Infrastructure, Transport, Regional Development and Communications**

## **Norfolk Island MPS DSC Contaminated Land Assessment**

October 2025

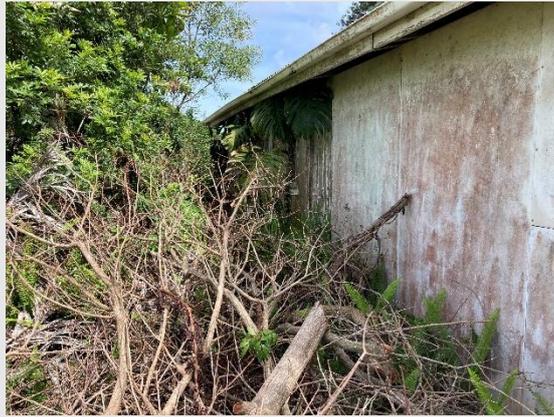
- Potential ACM fragments were observed on the ground surface within overgrown vegetation in areas surrounding the residential house and garage (Photograph 1 and Photograph 2).

**Photograph 1** – Overgrown vegetation surrounding residential house

Asbestos was detected below the ground surface adjacent to the house and inside the garage of the residential property. Fragments of potential ACM were also observed on the ground surface nearby to the house and / or the garage where over-grown vegetation limited visual assessment of the ground surface. The identification of asbestos in this area may be associated with the current state of disrepair of the existing structure, where ACM that comprise the buildings structure have become broken or damaged. The lateral extent of the asbestos identified within near surface soils in the fenced area that surrounds the house is unknown, further assessment is recommend to delineate the identified asbestos prior to any intrusive works which could potentially disturb or mobilise asbestos within surface soils. This may also present human health risks to future users / workers on the site.

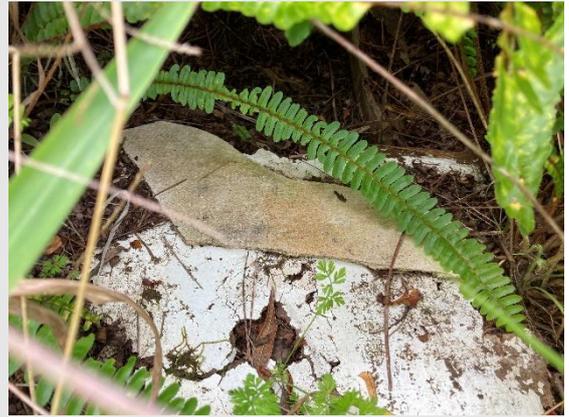
**Photograph 2** – Potential ACM within overgrown vegetation surrounding residential house

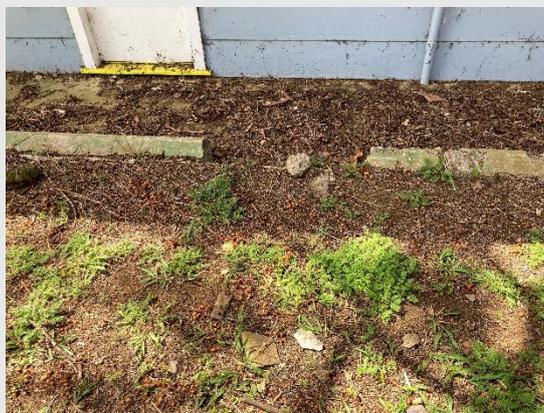
- Potential ACM fragments were observed on the ground surface east of Mawson House adjacent to the eastern property boundary / mechanical workshop (Photograph 3 and Photograph 4).

**Photograph 3** – Potential ACM fragments between Mawson House and mechanical workshop

Potential ACM fragments were also identified along the site boundary between Mawson House and the mechanical workshop, and on the unsealed access track that extends north from the site down the steep slope. It is recommended these ACM fragments are hand picked (“emu picked”) and disposed appropriately off site in consultation with NIRC.

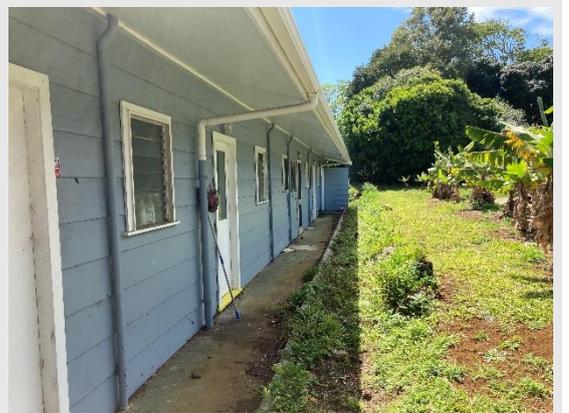
**Photograph 4** – General area where potential ACM fragments identified between Mawson House and mechanical workshop

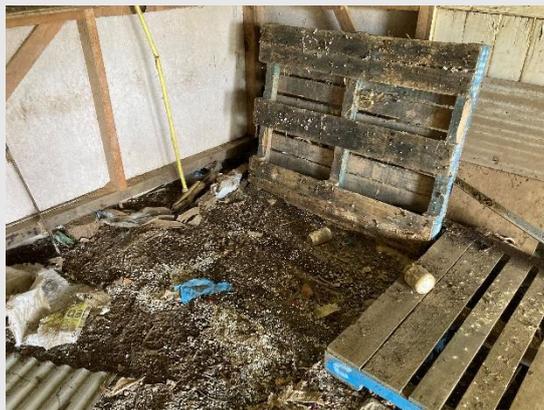
- Minor discolouration / surface staining was observed within the residential garage, no other olfactory signs of contamination were present (Photograph 5).

**Photograph 5** – Minor discolouration / surface staining within the residential garage below crates (location od HA02)

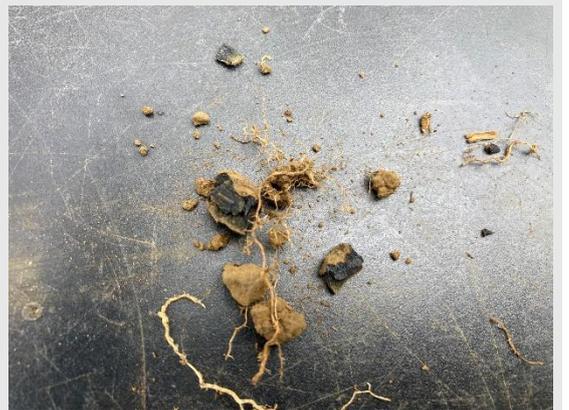
- Fragments of charcoal were noted within soil fill layers at BH01 and BH10. The presence of charcoal at BH01 is consistent with site interviews which identified a former bakery was previously located in this area, prior to burning down in the early 1970's. The origin of the charcoal at BH10 is unknown, however the material was comingled within a soil layer that extended to 1.3 mbgl (Photograph 6).

**Photograph 6** – Charcoal recovered from BH01

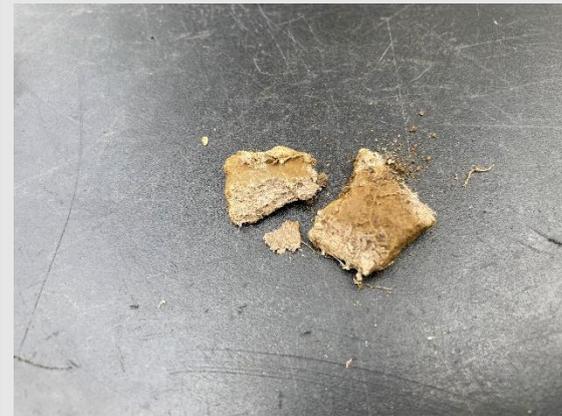
Based on anecdotal information gathered during the site inspection (refer to Section 4.2), the identification of asbestos at BH01 (along with trace charcoal), is considered to be associated with the former bakery that is understood to have burnt down during a fire in the early 1970's. Following the fire, the building was rebuilt and is the location of the current archive store room.

**Photograph 7** – ACM at BH01\_0.0-0.2

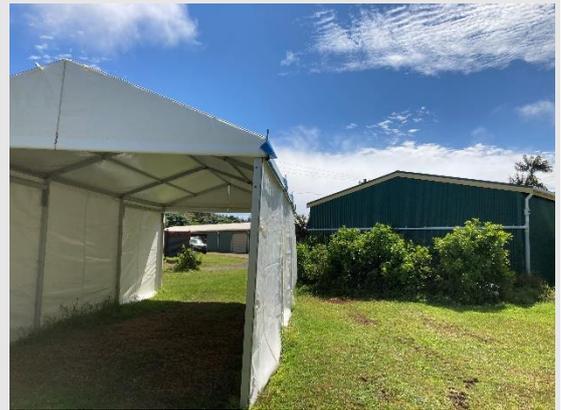
**Photograph 8** – Location of BH01, established adjacent to COVID-19 testing tent and archive store in the background

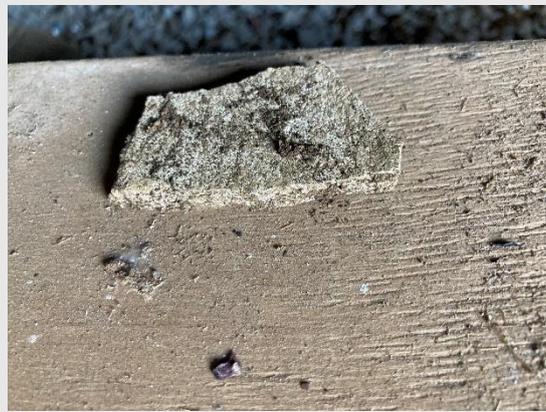
HA02 and TP02 are located in the southern portion of the site, adjacent to the unoccupied residential property. Both the house (adjacent to TP02) and the garage (HA02) were noted to be constructed of ACM. It is likely that the asbestos material detected at these locations has resulted from comingling of building materials and the underlying soil fill material. During the field investigation the residential house was noted to be in a state of disrepair with a number of the building surfaces, inferred as potential ACM, containing cracks or broken sheets which may have contributed to the identification of ACM.

**Photograph 9** – ACM at TP02\_0.0-0.2

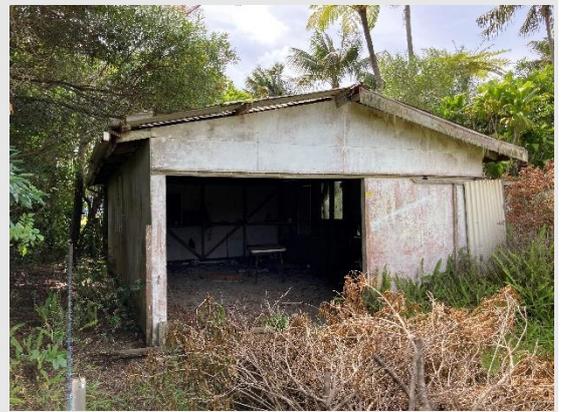
**Photograph 10** – Location of HA02, established inside residential garage

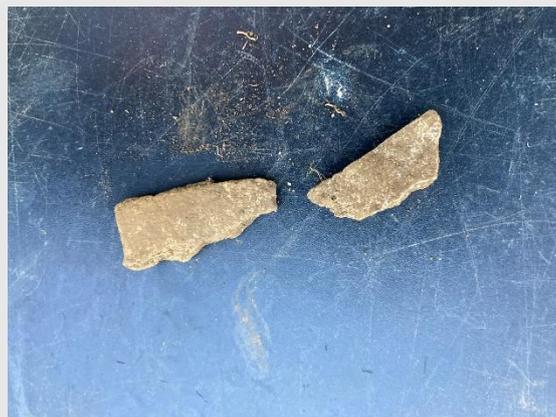
**Photograph 11** – ACM at TP02\_0.0-0.2

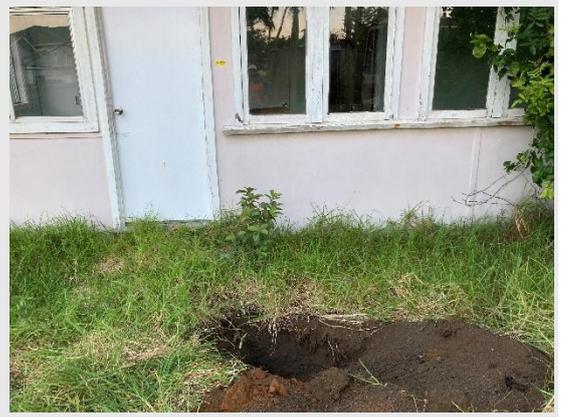
**Photograph 12** – Location of TP02, established adjacent to residential house

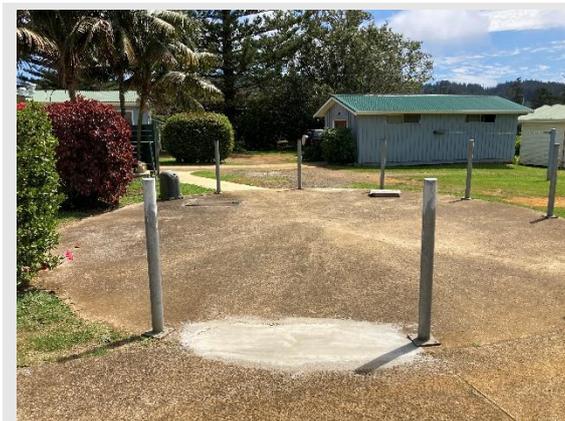
**Photograph 13** – Below ground water storage tank formerly used to store groundwater from Norfolk Island Airport

The detections of PFAS in the northern portion of the site may be attributed to the identified former use of groundwater originating from the Norfolk Island Airport, which was previously stored in a below ground tank located adjacent to the maintenance workshop. Staging plans for the proposed MPS facility indicate the below ground (water) tank and nearby laundry facility will require demolition. It is recommended that the contamination status of the tank, any adjoining infrastructure and the surrounding soils at depth are identified prior demolition to inform appropriate management and disposal of potentially contaminated materials. Additionally, based on the detection of PFAS, the depth to groundwater at the site may require future assessment.

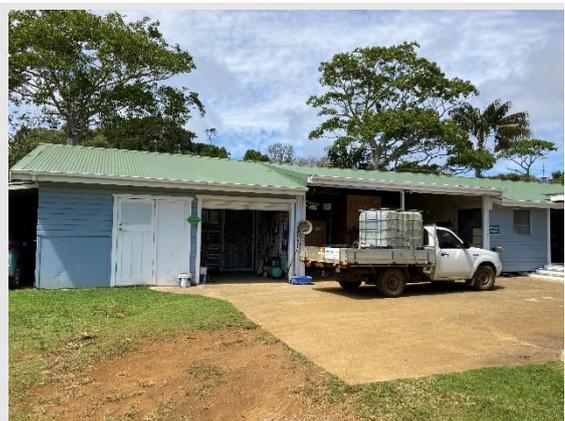
- PFAS was detected above the human health assessment criteria in one sample collected from near surface soils adjacent to the maintenance workshop in the northern portion of the site. The detections of PFAS may be attributed to the identified former use of groundwater originating from the Norfolk Island Airport and previously stored in a below ground tank located adjacent to the maintenance workshop.

**Photograph 14** – The maintenance workshop is located adjacent to water tank on an adjoining hardstand. HA03 was established on the grass next to workshop building.
