LAYOUT PLAN 0-150  
1:250 at A1  
1:500 at A3

LONGSECTION 0-150  
1:250 at A1  
1:500 at A3

Sheet Title  
Pumpstation 6 Details

Sheet Title  
Typical Details  
1 of 3

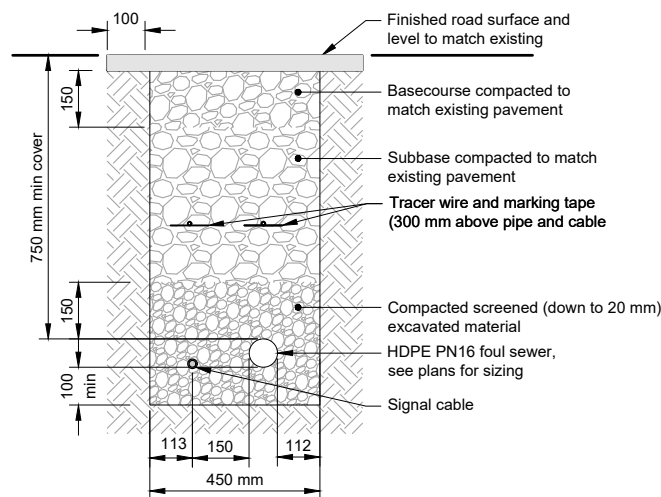
TRAFFICABLE (SEALED ROADS)  
TYPICAL TRENCH DETAIL  
1:10 at A1  
1:20 at A3

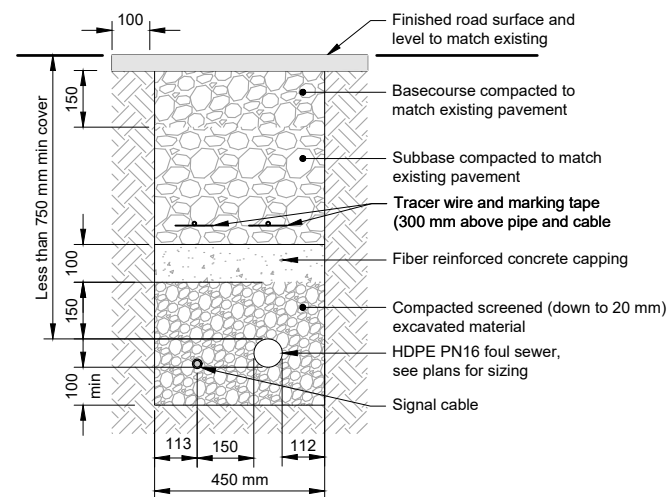
TRAFFICABLE (SEALED ROADS) - COVER LESS THAN 750MM  
TYPICAL TRENCH DETAIL  
1:10 at A1  
1:20 at A3

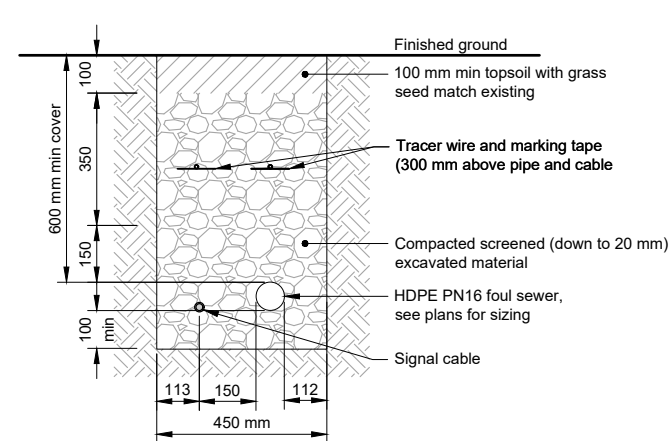
NON-TRAFFICABLE  
TYPICAL TRENCH DETAIL  
1:10 at A1  
1:20 at A3

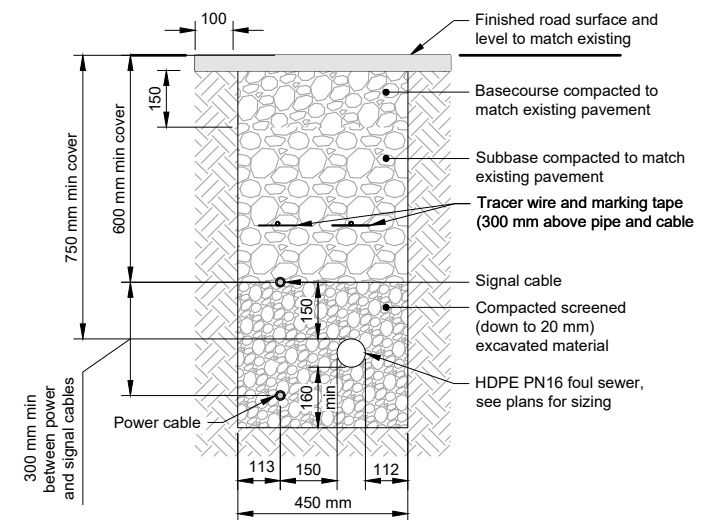
TRAFFICABLE (SEALED ROADS)  
TYPICAL TRENCH DETAIL  
COMBINED POWER AND SIGNAL CABLES  
1:10 at A1  
1:20 at A3

D = External Diameter of Pipe

Trench to be Reinstated to Match Existing Levels

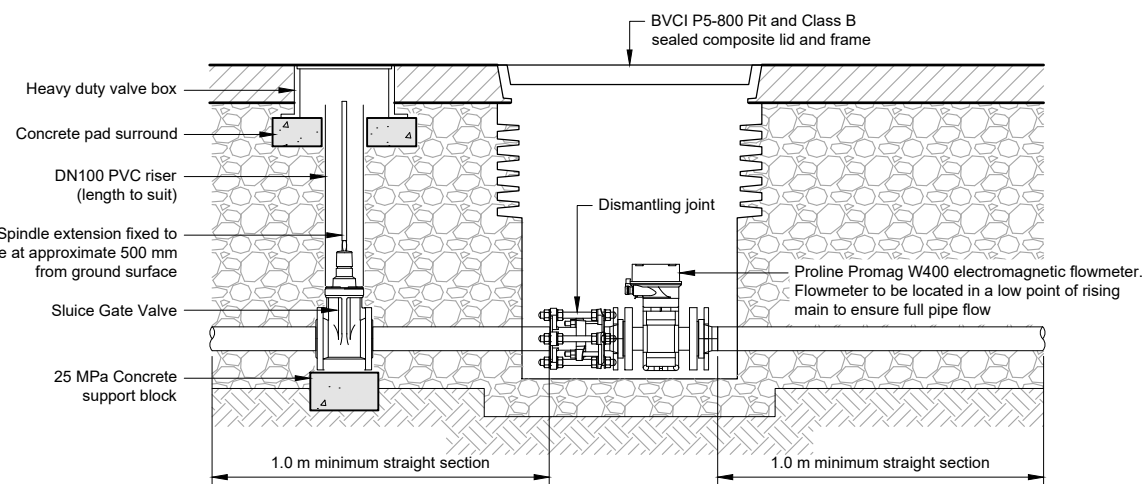
FLOW METER DETAIL  
1:10 at A1  
1:20 at A3

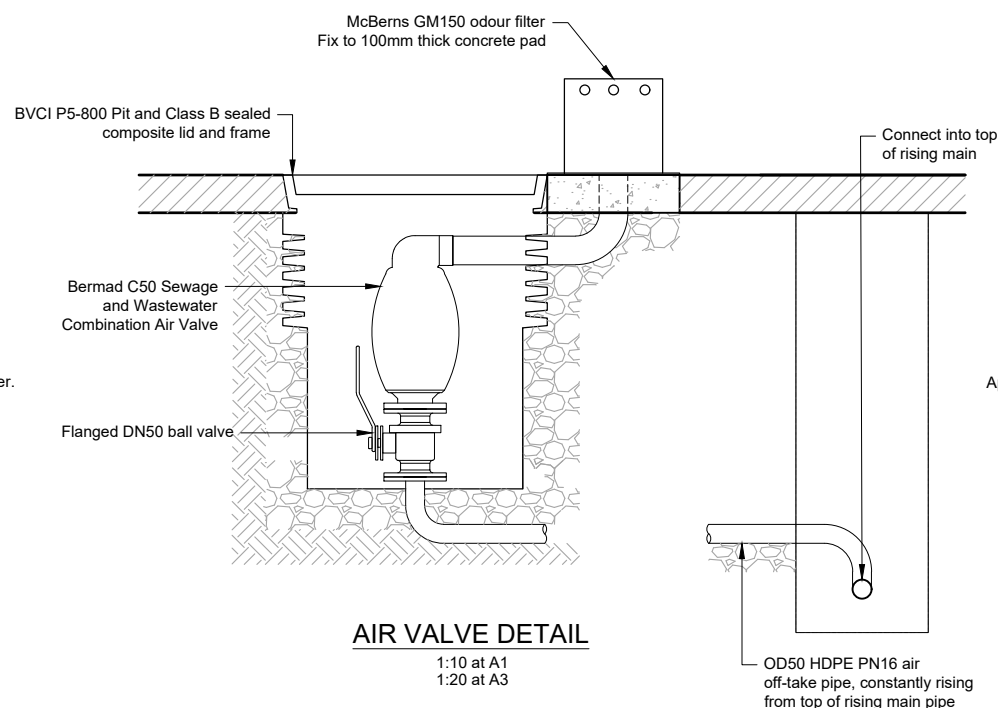
AIR VALVE DETAIL  
1:10 at A1  
1:20 at A3

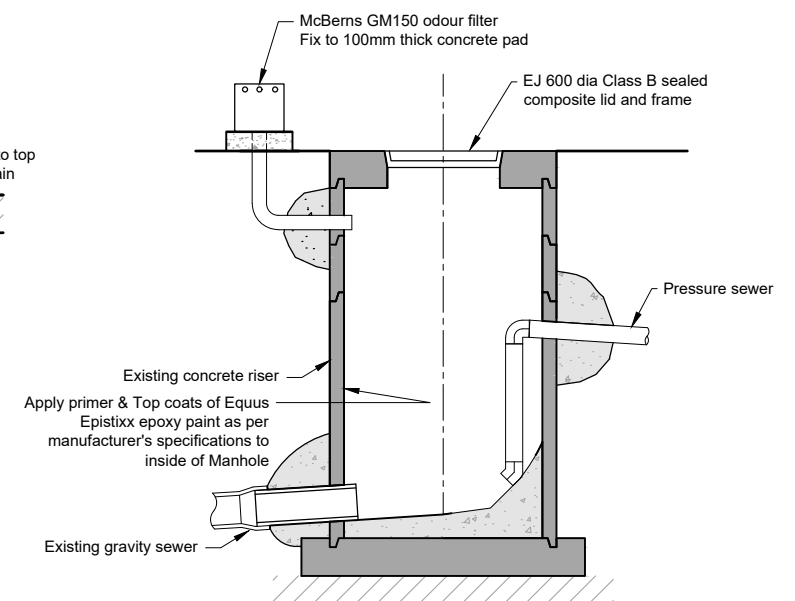
MANHOLE DETAIL  
1:20 at A1  
1:40 at A3

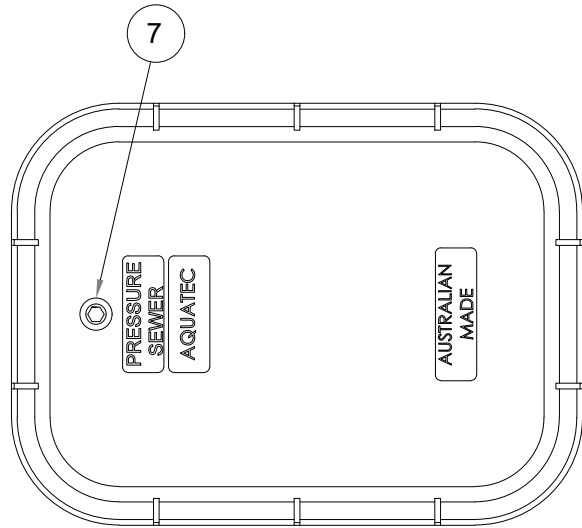
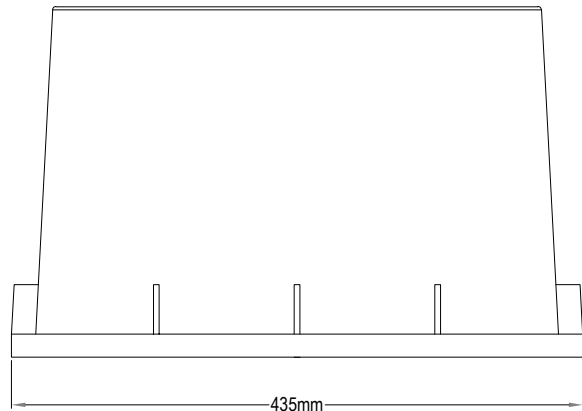
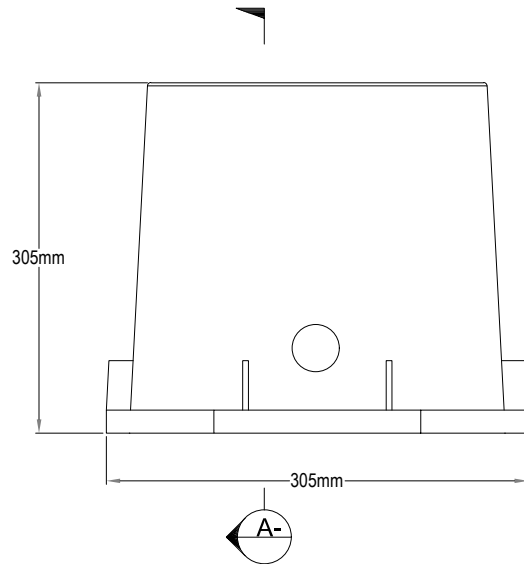
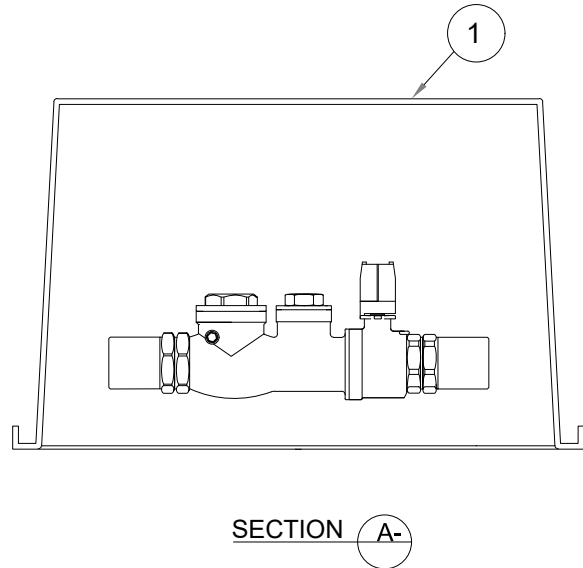
AQUATEC BOUNDARY CONNECTION KIT  
NTS

NOTES:	
1	POLYETHYLENE ONE PIECE PIT WITH COVER, CLASS A
2	GR316 S/S BALL VALVE, FULL BORE
3	GR316 S/S PUMP OUT TEE
4	GR316 S/S PLUG
5	GR316 S/S SWING CHECK VALVE, FULL BORE
6	PE MALE THREAD ADAPTER
7	GR316 S/S BOLT

NOTE:  
- FITTINGS 2 to 5 IS A ONE PIECE ASSEMBLY  
- ITEM 6 ALSO AVAILABLE IN BRASS AND 316 S/S

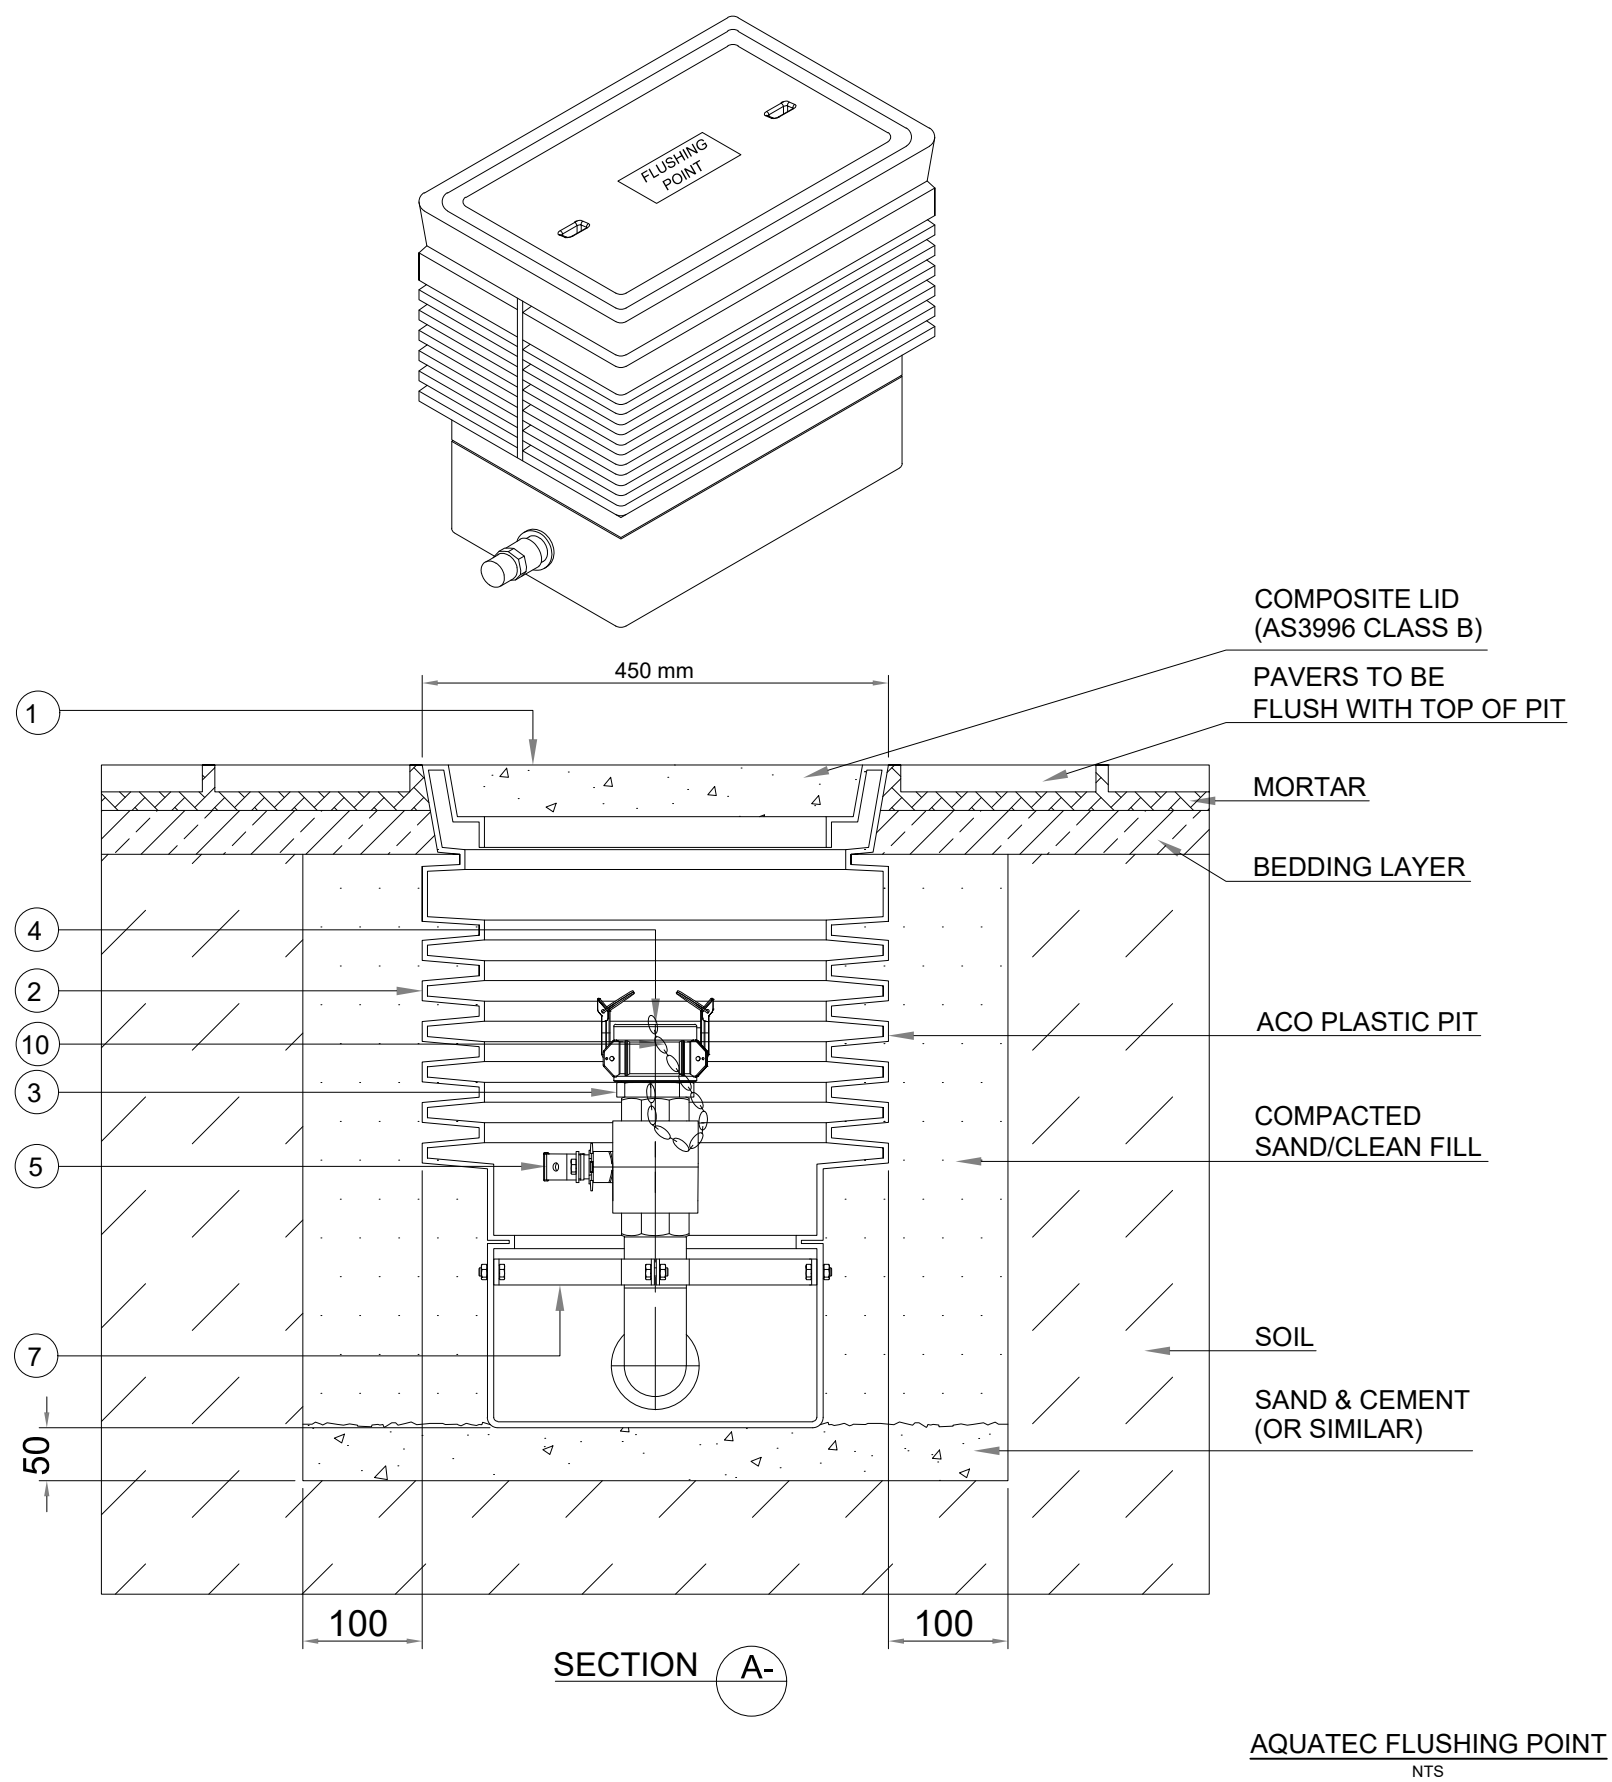
NOTES:	
1	COMPOSITE 'CLASS B' COVER TO SUIT (AS3996)
2	POLYETHYLENE PIT
3	POLYETHYLENE MALE CAMLOCK
4	POLYETHYLENE FEMALE CAMLOCK DUST CAP
5	GR316 S/S BALL VALVE, FULL BORE, LOCKABLE EYELET
6	GR 316 S/S TRACER WIRE (BY OTHERS)
7	GR316 S/S PIPE SUPPORT BRACKET
8	GR316 S/S PIPEWORK
9	POLYETHYLENE TRANSITION COUPLER (CONNECTION BY CIVIL CONTRACTOR)
10	GR316 S/S CHAIN
11	RUBBER UNISEAL
12	FITTINGS & MATERIALS TO BE IN ACCORDANCE WITH AUSTRALIAN STANDARDS

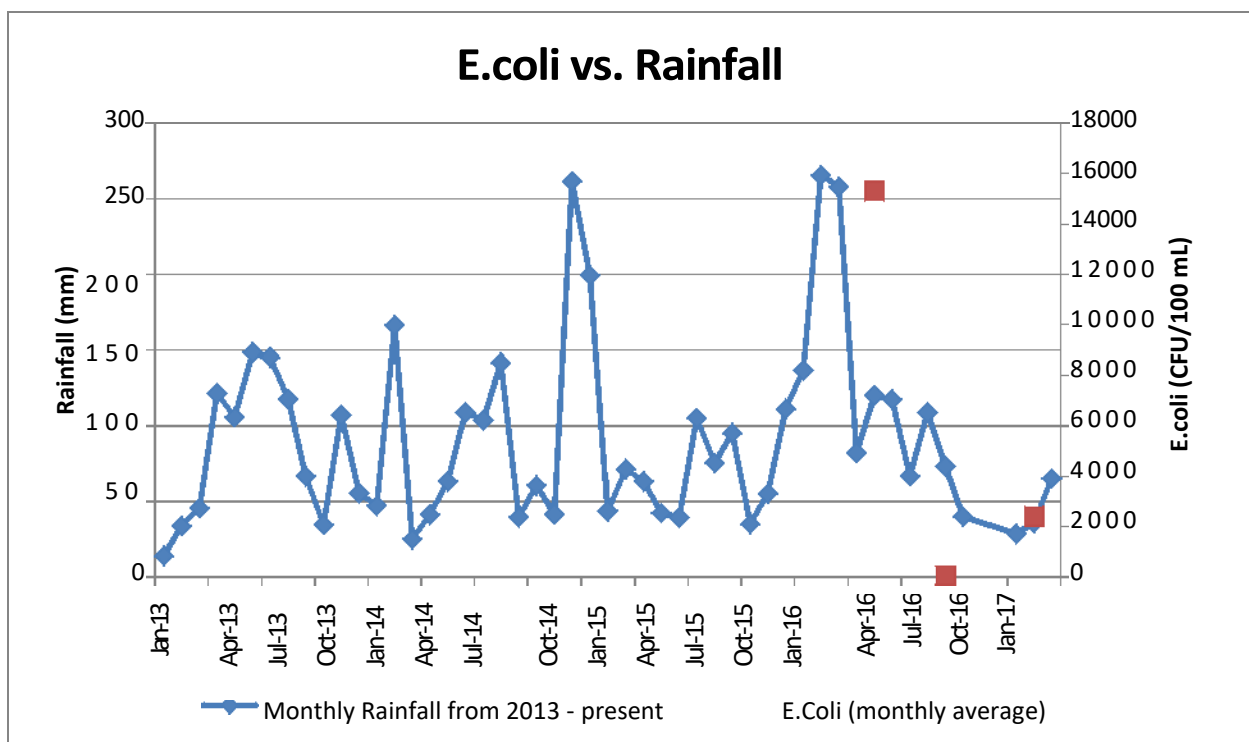
Figure 2 Rainfall events vs. *E.coli* measurements (2013 – February 2017)

The graph supports historical trends that observed *E.coli* concentrations increased directly after large rainfall events and is considered to provide rationale to the variations in reported *E.coli* concentrations over time.

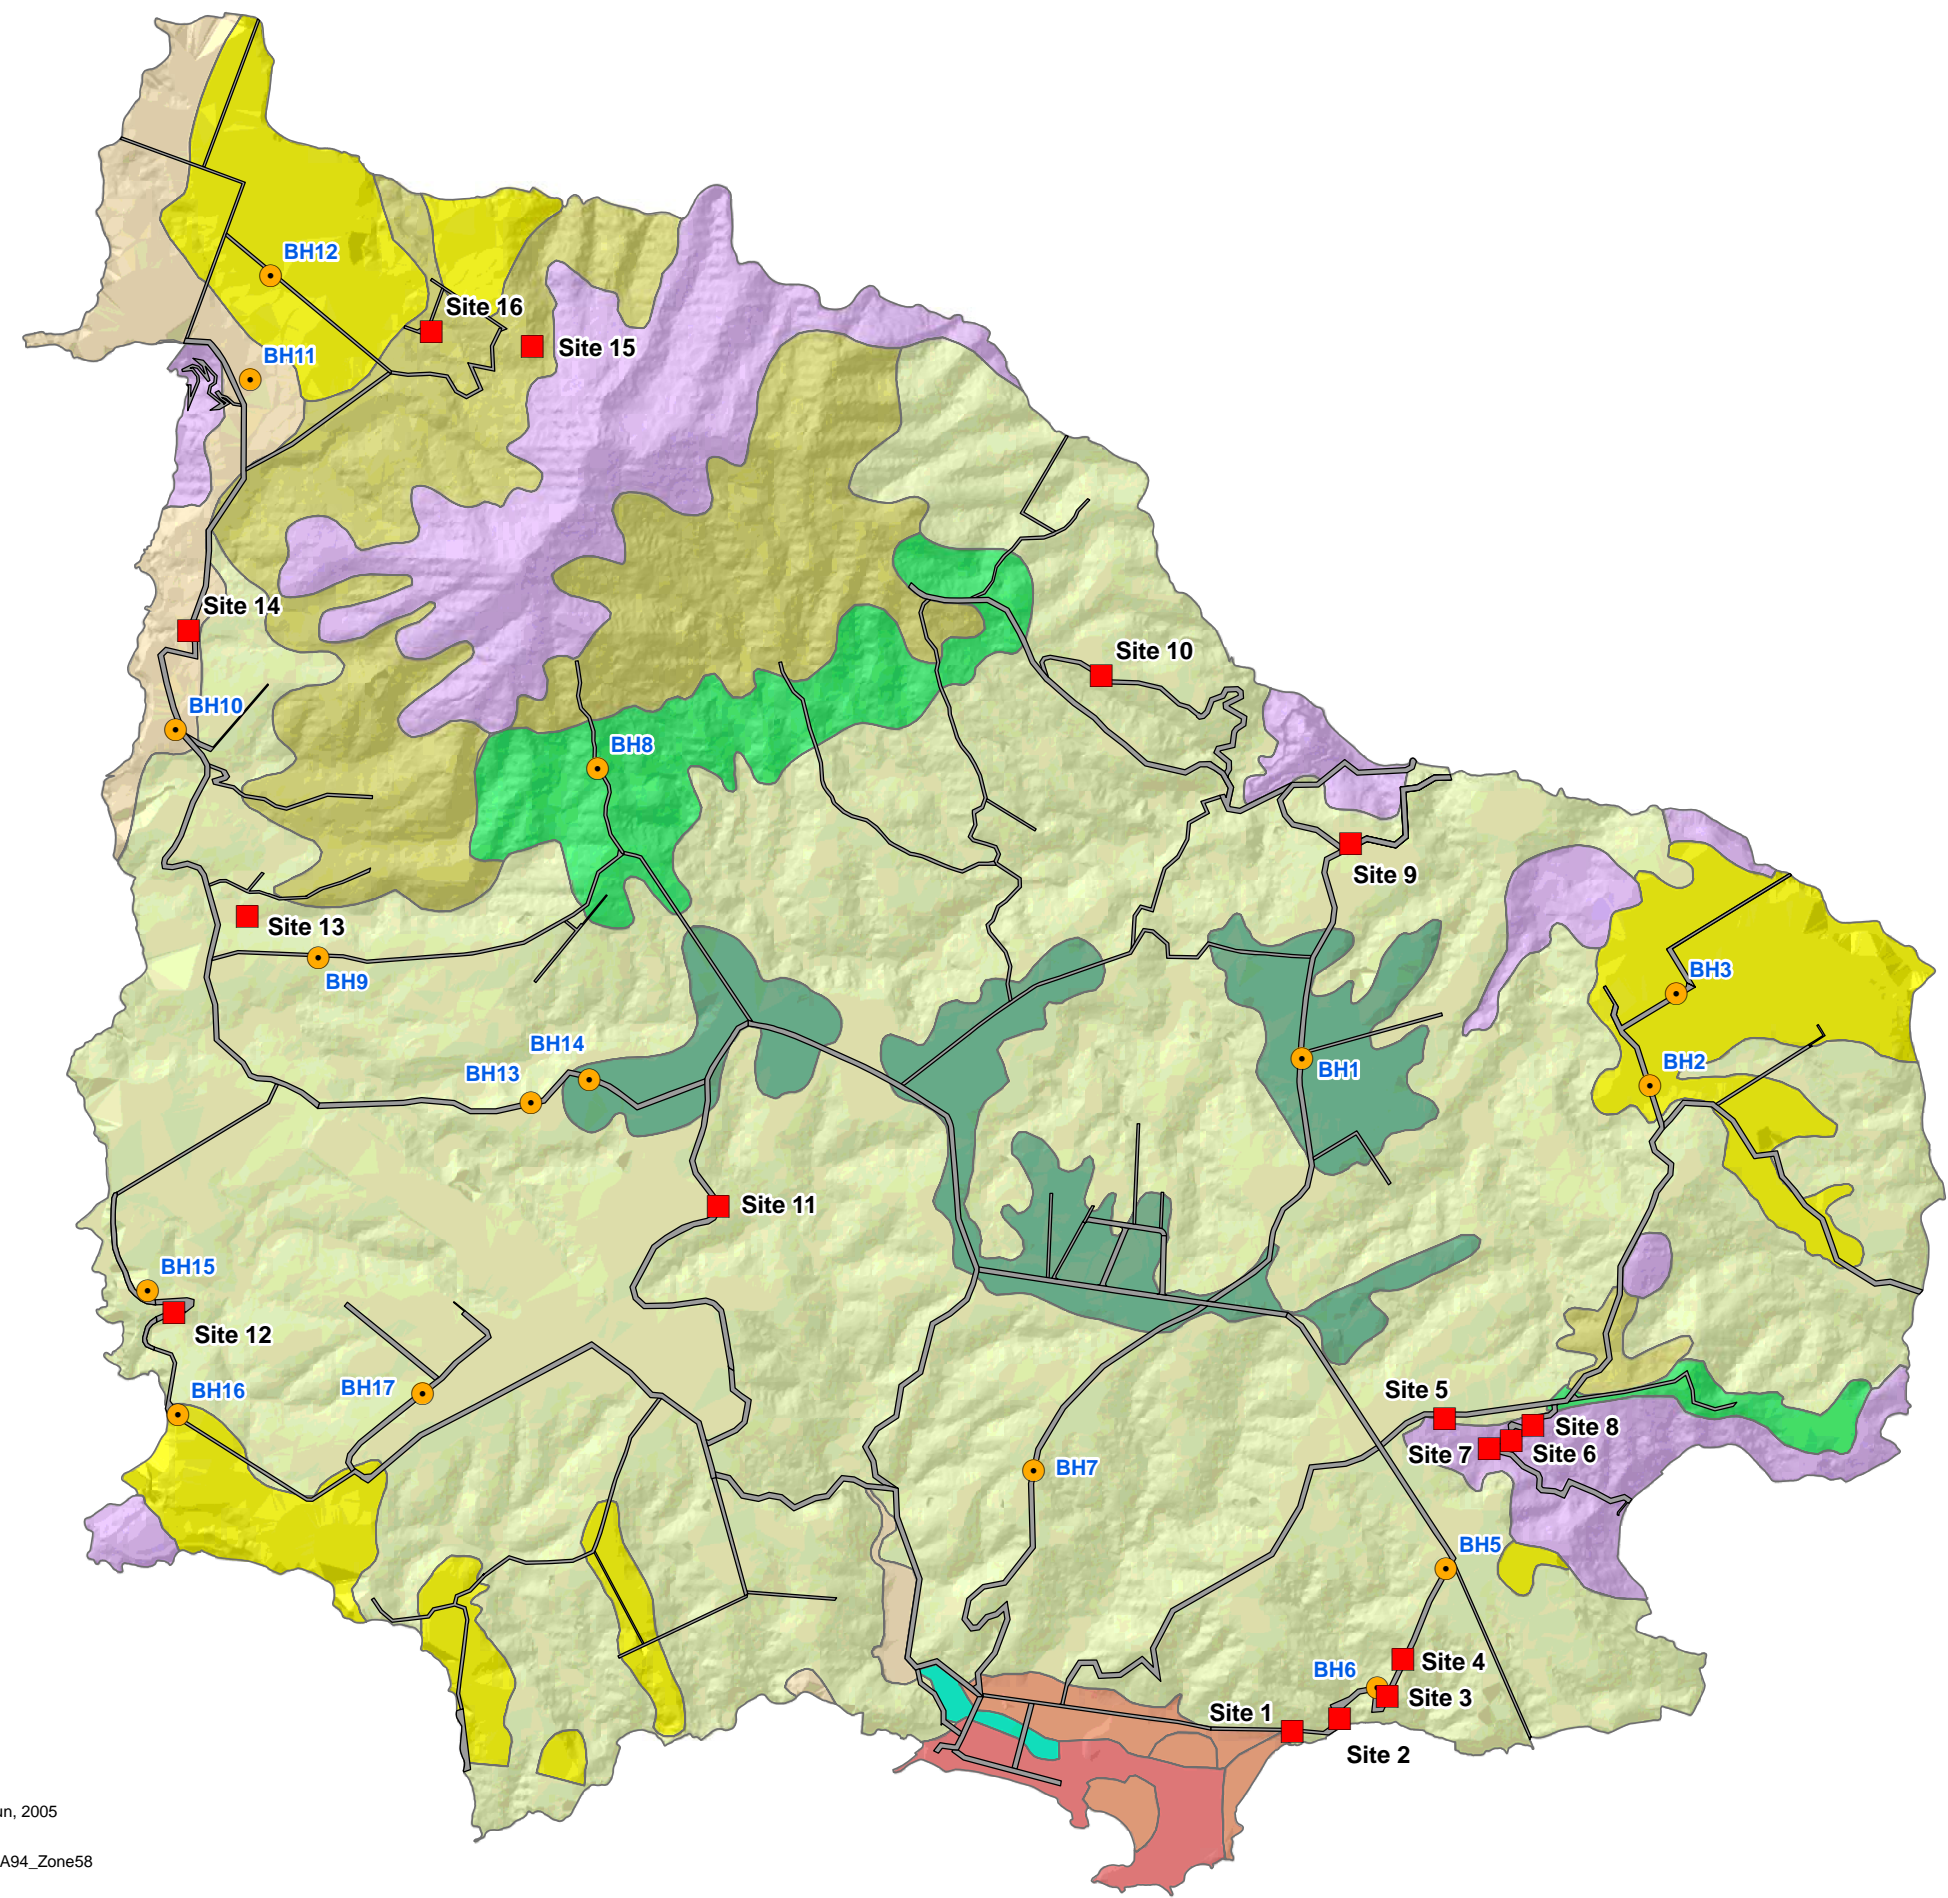
- Site Mapping Location
- Borehole
- Soil Types \***
- Balsaltic Colluvium mixed with calcareous sand
- Emily Bay calcareous sand
- Middlegate gravelly clay
- Mt Pitt Clay
- Palm Glen clay
- Rooty Hill Clay
- Selwyn Clay
- Steeles Point Clay
- Unnamed shallow stony soils on basalt
- Unnamed swamp soil
- Soil Types

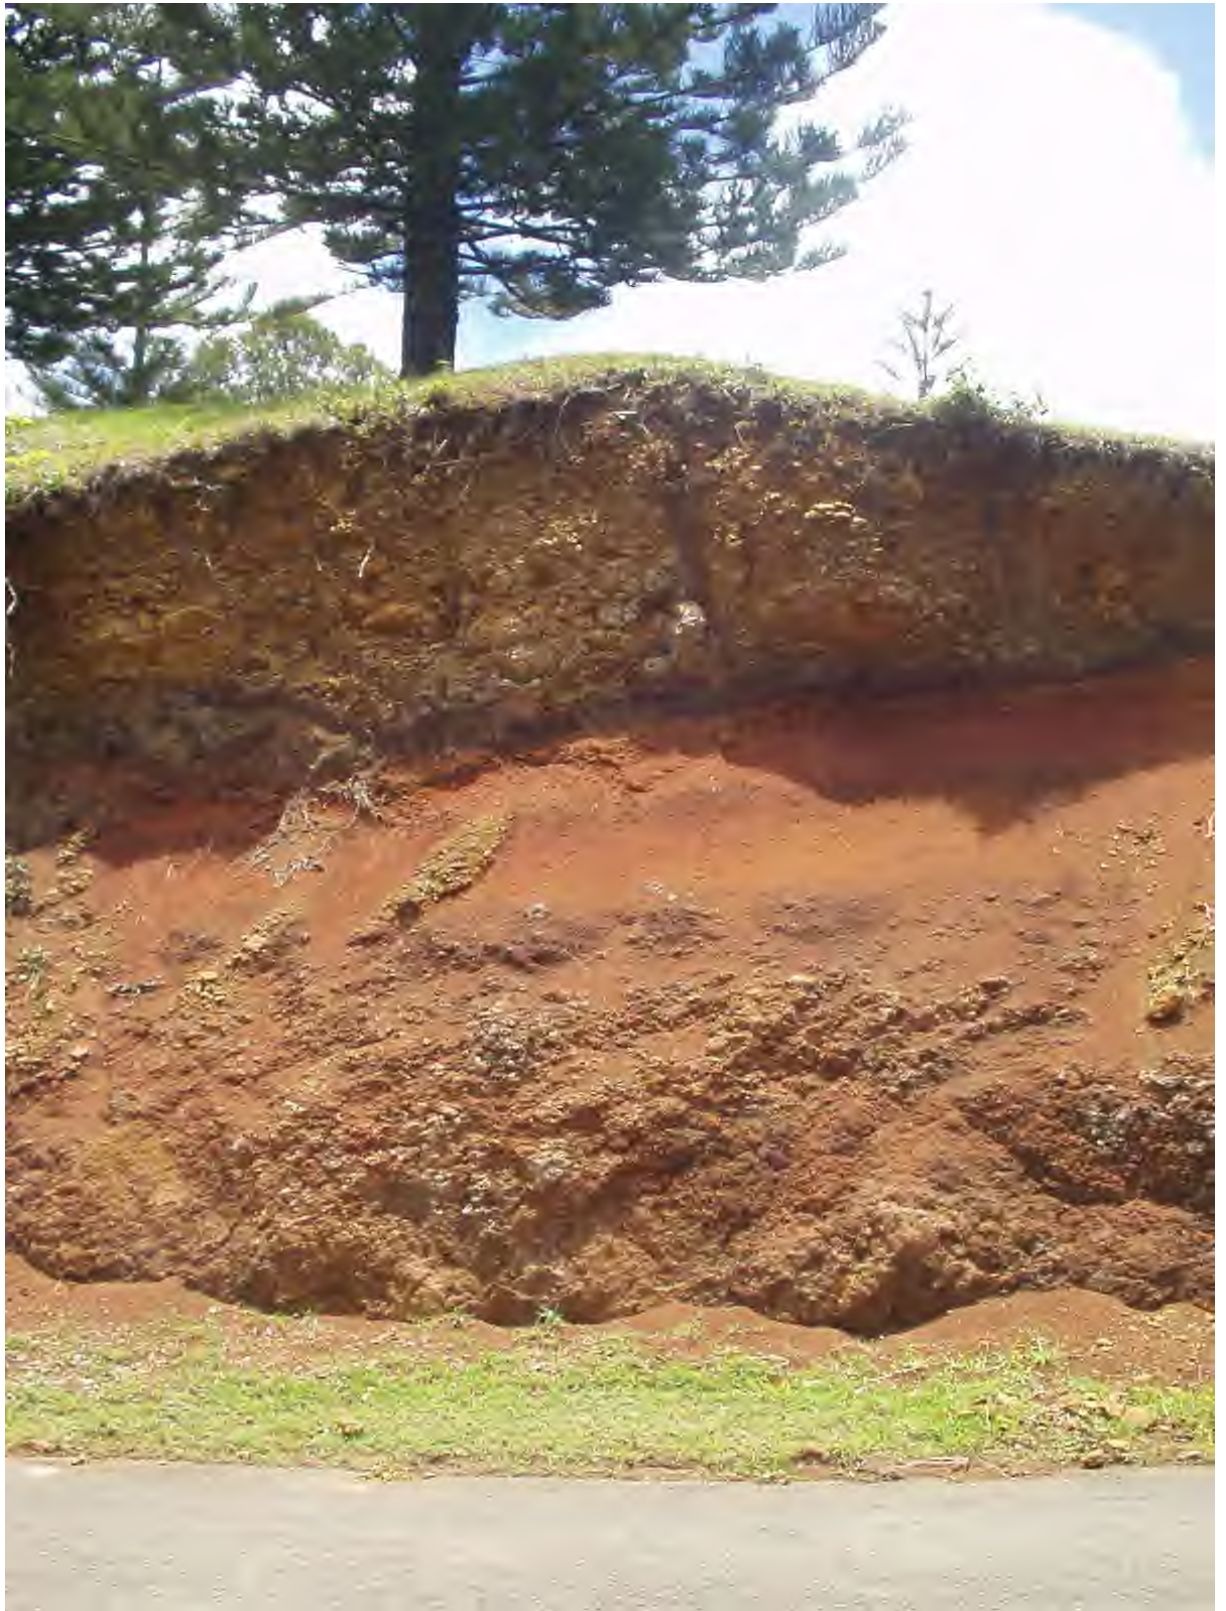
Plate 1: Basalt flow overlying a residual soil formed by a previous basalt flow.

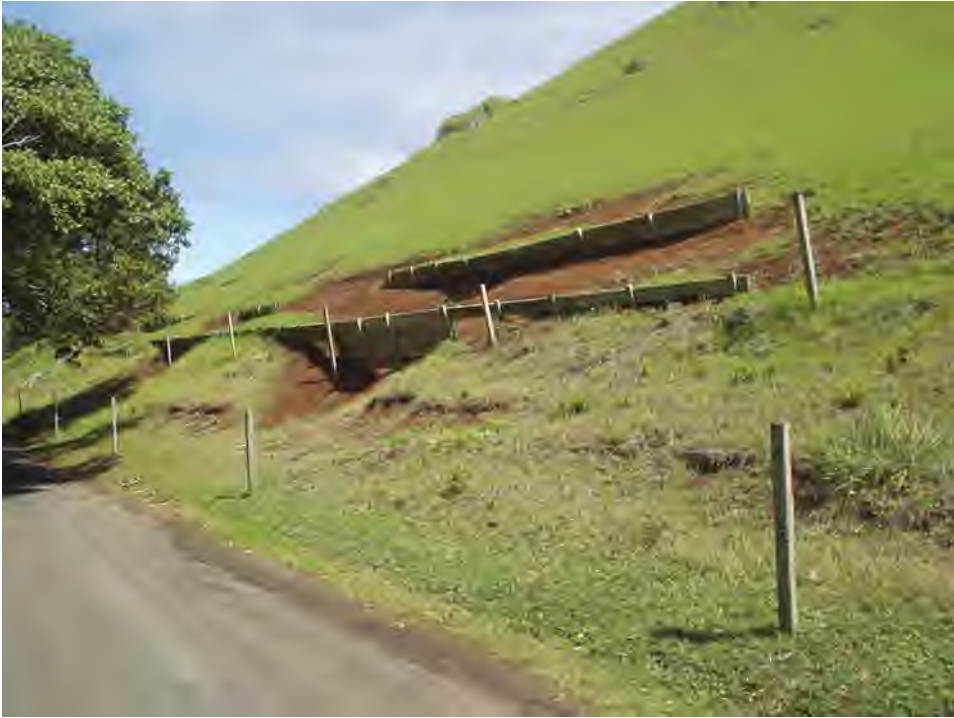
<b>Site: 1</b>	<b>Location:</b> Quality Row, Kingston
<b>Coordinates:</b> E: 58 789142      N: 6782091	
<b>Description:</b>	
<p>Timber post and panel retaining walls stepped on the slope. Posts are tilting down slope, due to soil creep movements and erosion. The retaining walls are possible supporting a previous erosion feature, or an old surface slump.</p> <p>The slope above falls at 30° to 35°, and displays regular terracing/stepping of the ground surface, indicating surface creep. This is likely to be exasperated by stock contouring around the steep slopes. Fresh basalt boulders are evident scattered thinly over the slope.</p>	
<b>Photograph:</b>

A photograph showing a steep, grassy hillside. A series of wooden posts and panels are driven into the ground, forming a retaining wall that follows the contour of the slope. The slope appears to be eroded, with exposed reddish-brown soil visible behind the wall. The hillside is covered in green grass, and there are some scattered rocks or boulders. A paved road is visible in the foreground on the left, and a line of trees is on the far left. The sky is blue with some clouds.

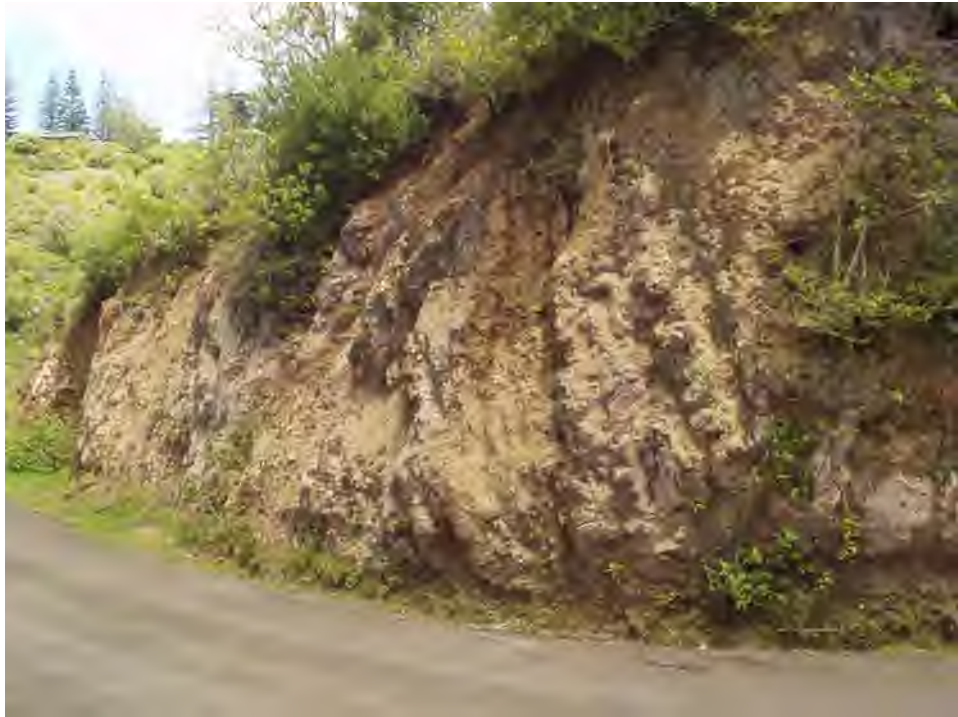
**Description:** Near vertical road cutting up to about 5m high exposing highly weathered Tuff/Basalt, low strength, grey, fine grained, vesicular, highly fractured and jointed. A thin (about 0.5m thick) residual soil of high plasticity silty clay overlies the rock.

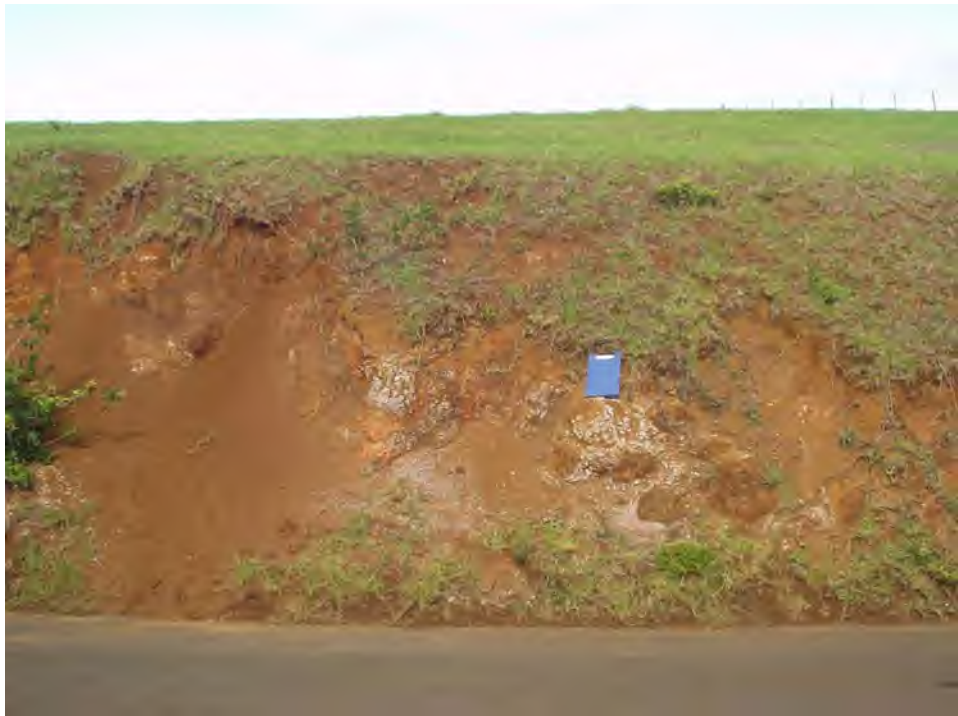
**Description:** A road cutting a 3m deep through a broad shallow ridge exposing residual soil over weathered basalt. The residual soils are about 1.2m deep consisting of well structured silty clay, high plasticity, orange brown and well structured with some basalt gravel. The basalt is extremely to highly weathered, very low to low strength, pale grey and highly fractured, often displaying spheroidally weathered core stones.

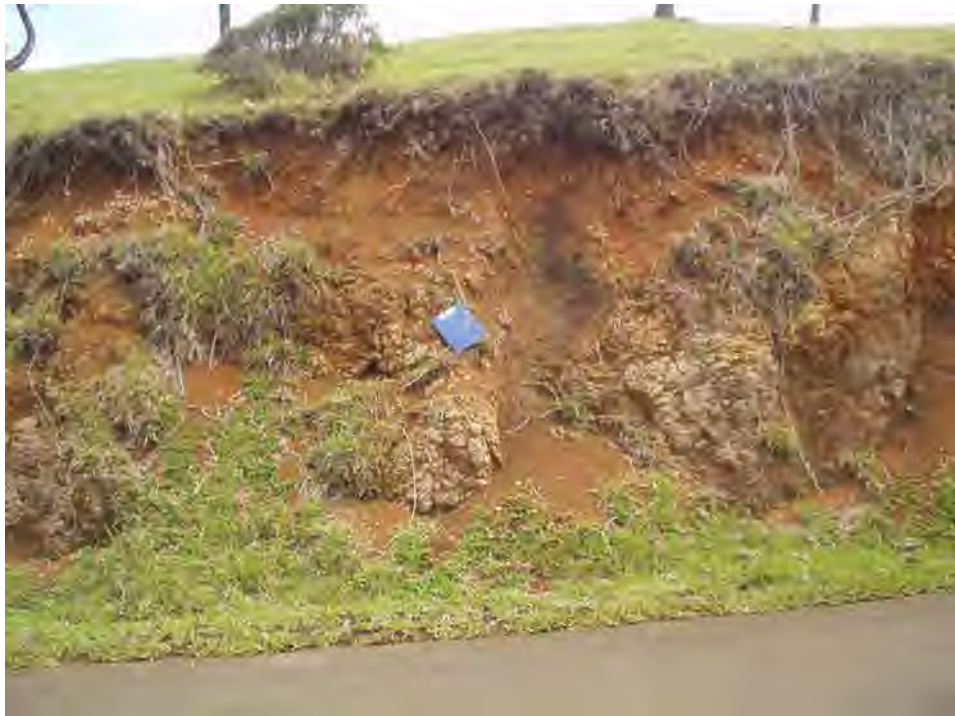
**Description:**    A road cutting a 3m deep on the side of a hill exposing residual soil over weathered basalt. The residual soils are about 1.2m deep consisting of well structured silty clay, high plasticity, orange brown and well structured with some basalt gravel. The basalt/tuff is extremely to highly weathered, very low to low strength, pale grey and highly fractured.

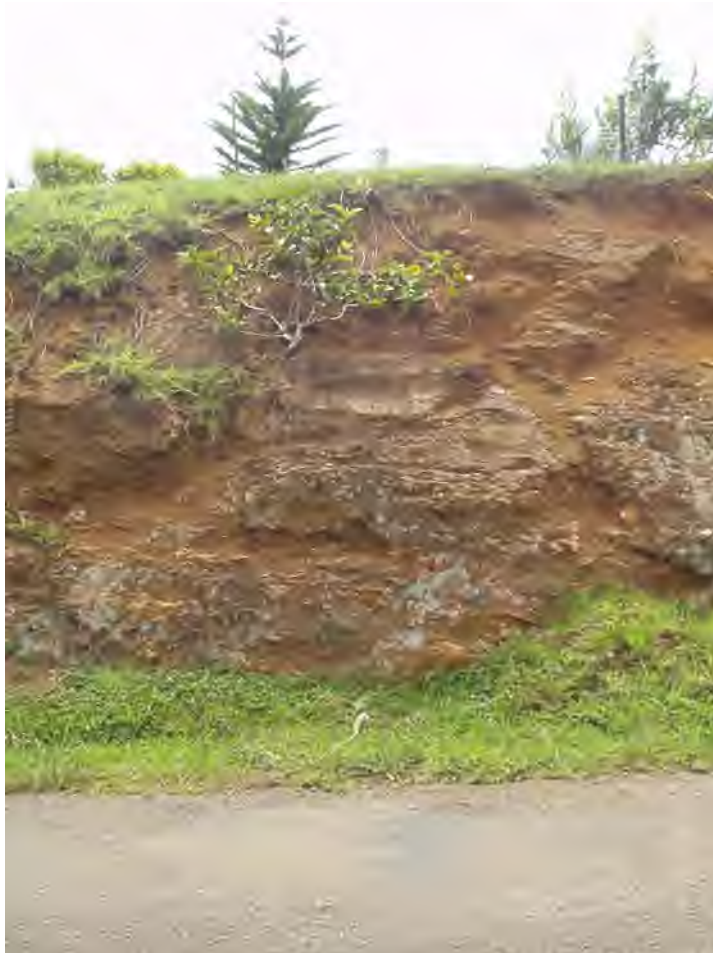
**Description:** A road cutting a 2.5m deep through a broad shallow ridge exposing residual soil over weathered basalt. The residual soils are about 0.5m deep consisting of silty clay, high plasticity, orange brown and well structured with some basalt gravel. The basalt is highly weathered, very low to low strength, pale grey and highly fractured.

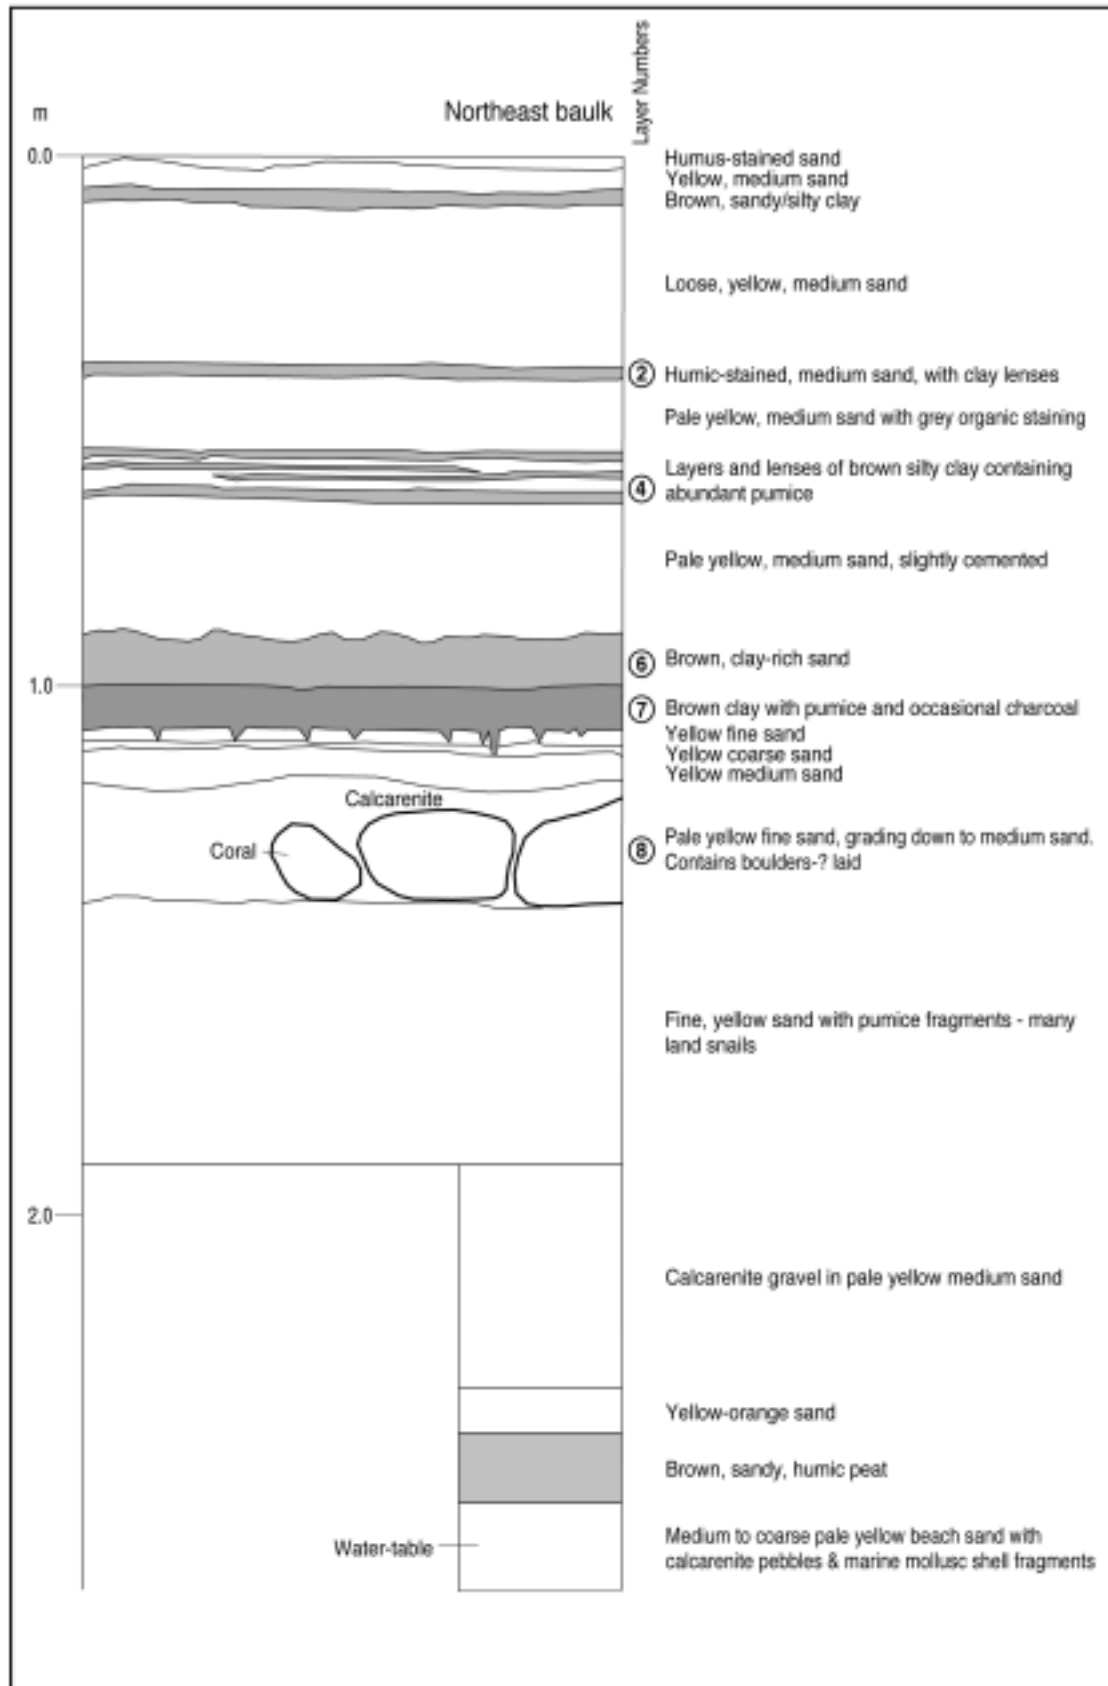
**Figure 2.** Stratigraphy of trench CB95:01 in Cemetery Bay.

The stratigraphy at this site consisted of layers of carbonate sand interleaved with layers of sand or silt-enriched clay (Fig. 2). The upper of these latter formed part of the current soil horizon (included for archaeological recording purposes in layer 1), and the others were designated layers 2, 4 and 6. The important point to note about these layers is that they are not palaeosols. There is no evidence of soil development. Rather the material

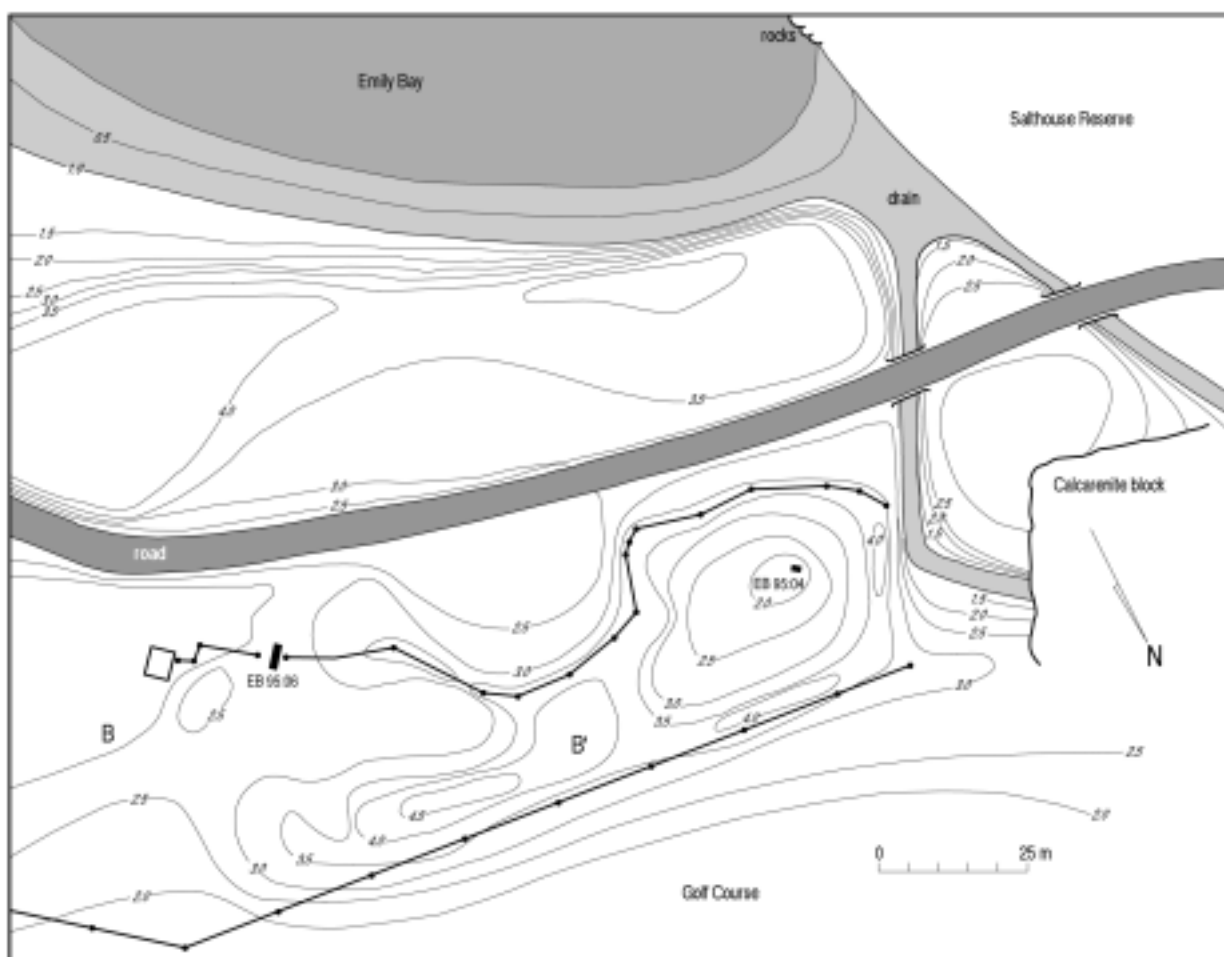
**Figure 5.** Location of Trenches EB95:04 and EB95:06 (incorporating EB95:05) at Emily Bay in 1995.

The digger was then moved to the western end of Emily Bay within a fenced-in Norfolk pine plantation (Figs. 3, 5).

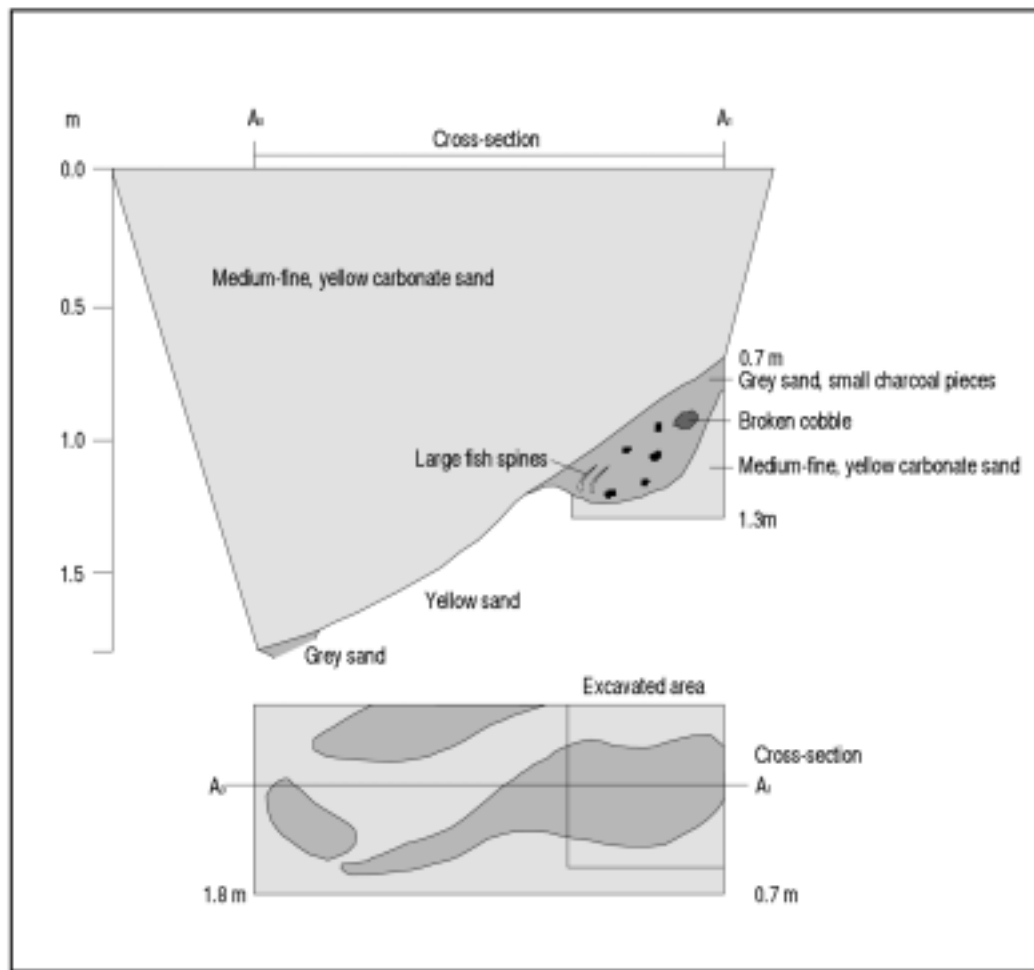
**Figure 6.** Stratigraphy and cross-section of Trench EB95:04.

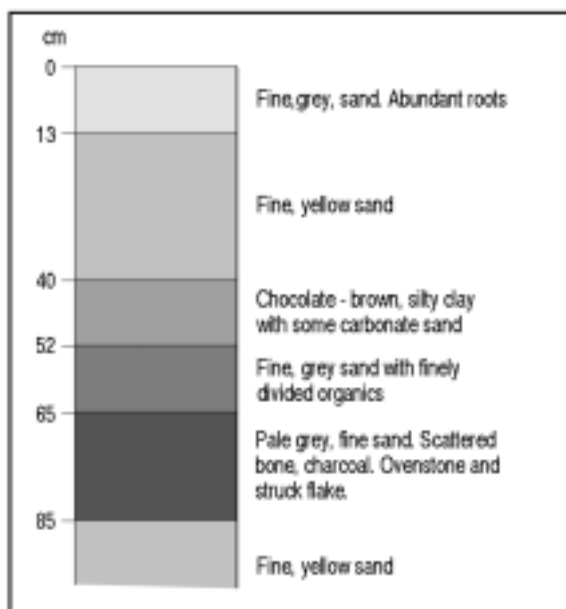
**Figure 7.** Stratigraphy of Trench EB95:05.
